THE HISTORY OF RECLAMATION
LEGISLATION AND ITS IMPACT
ON RECLAMATION PRACTICES IN
COLUMBIANA COUNTY, OHIO

A Thesis

Chris R. Cowan

The Ohio State University
1985

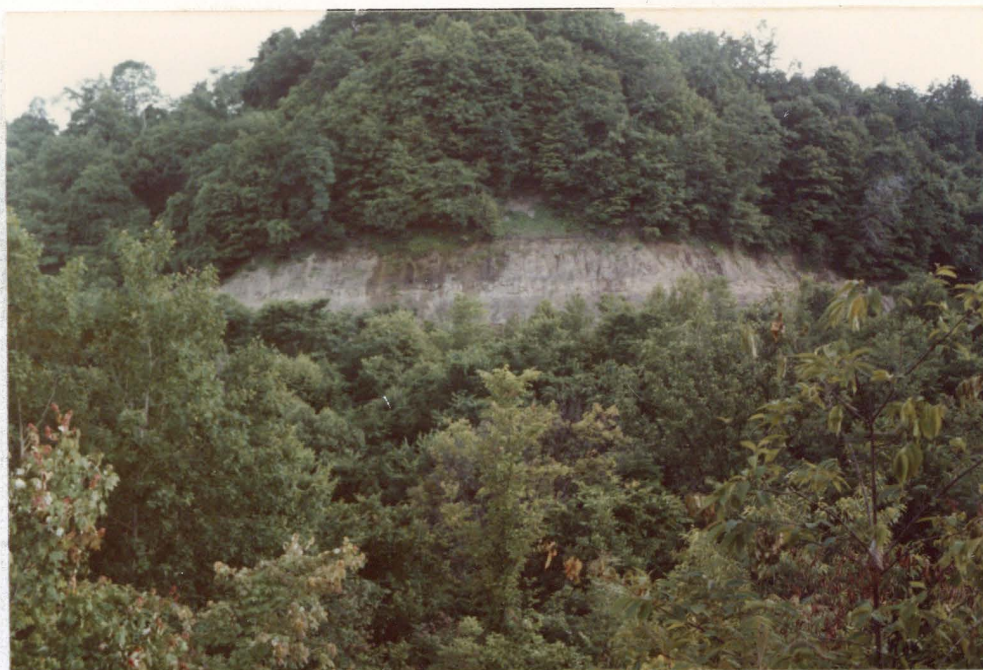
Figures 11 through 19 exemplify present conditions of the Island Run site. Figure 11 shows highwall of final cut. Figure 12 depicts dangerous overhang on highwall exposure and Figure 13 shows talus at the foot of same highwall. Figure 14 depicts a pond formed in final cut between highwall and spoil bank. Figure 15 shows an ungraded peak of spoil material with sparse vegetation. Figure 16 is a photo of a

Figure 11. Highwall on southern face of Island Run site.

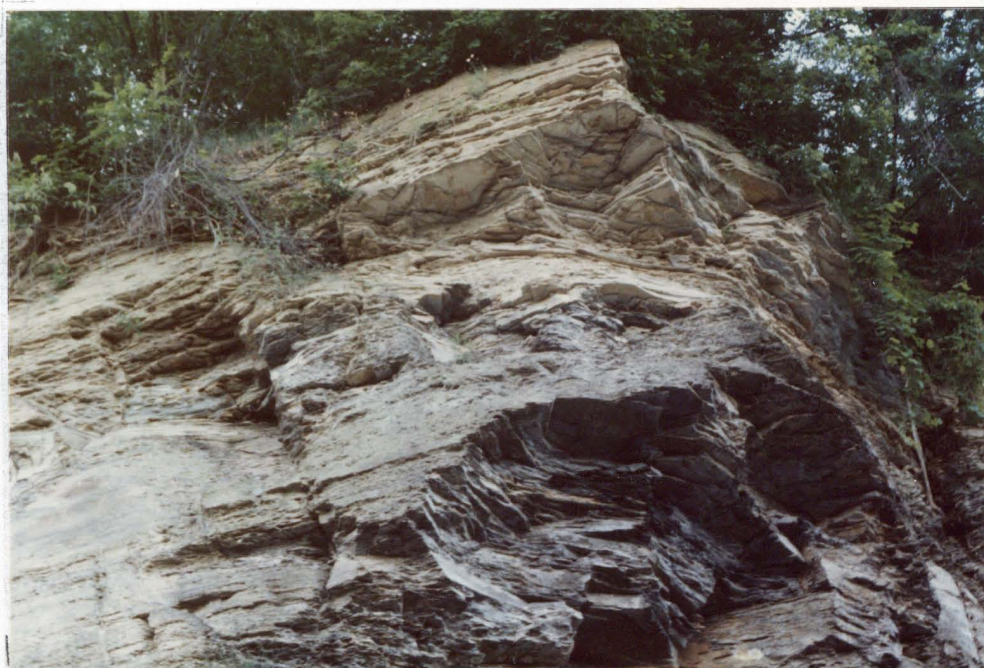
Figure 12. Dangerous overhang on northern highwall.

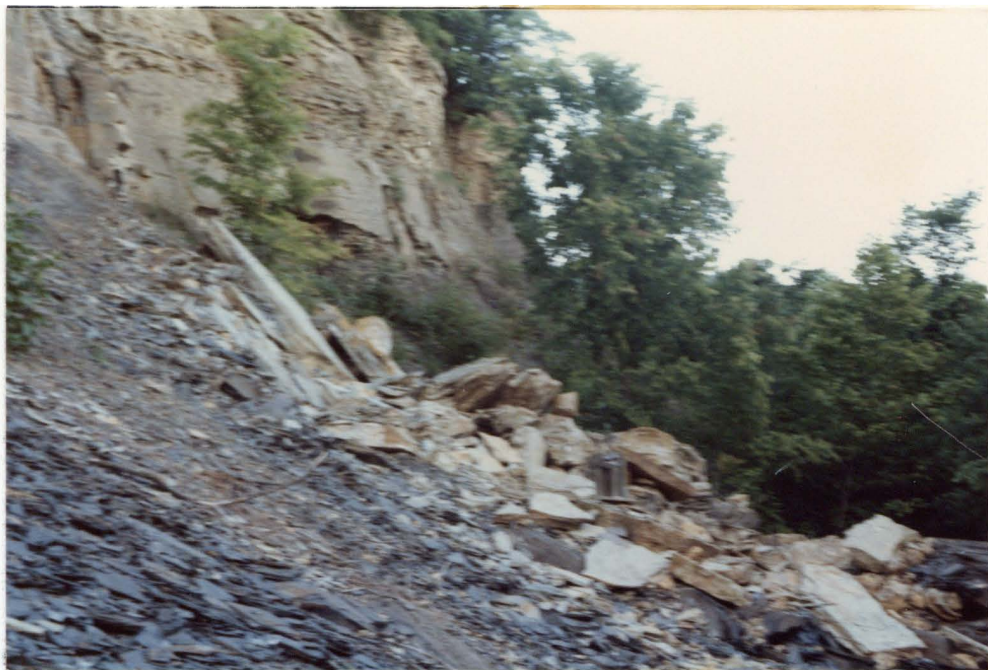
Figure 13..Talus at foot of highwall in Figure 12.

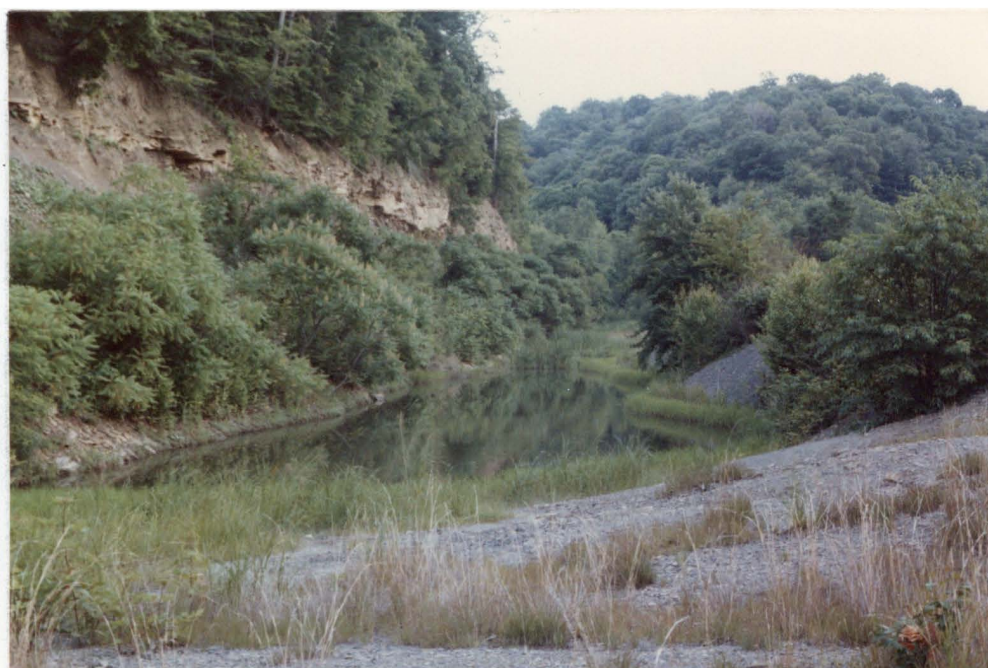
Figure 14. Impoundment of water between highwall and spoil bank.

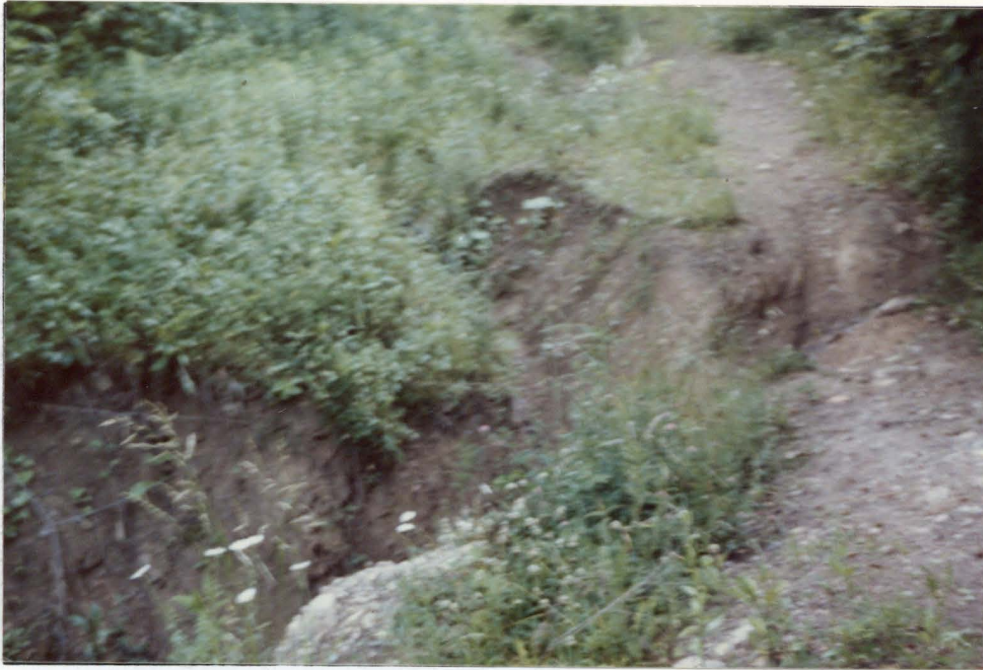
graded spoil bank. Figure 17 depicts a deep erosional rill in a graded spoil bank. Figure 18 is an example of sandstone talus on the slope of a spoil bank and Figure 19 is a picture of sulfates contaminating a small tributary of Little Beaver Creek.

Figure 17. Erosional rill in graded spoil bank.

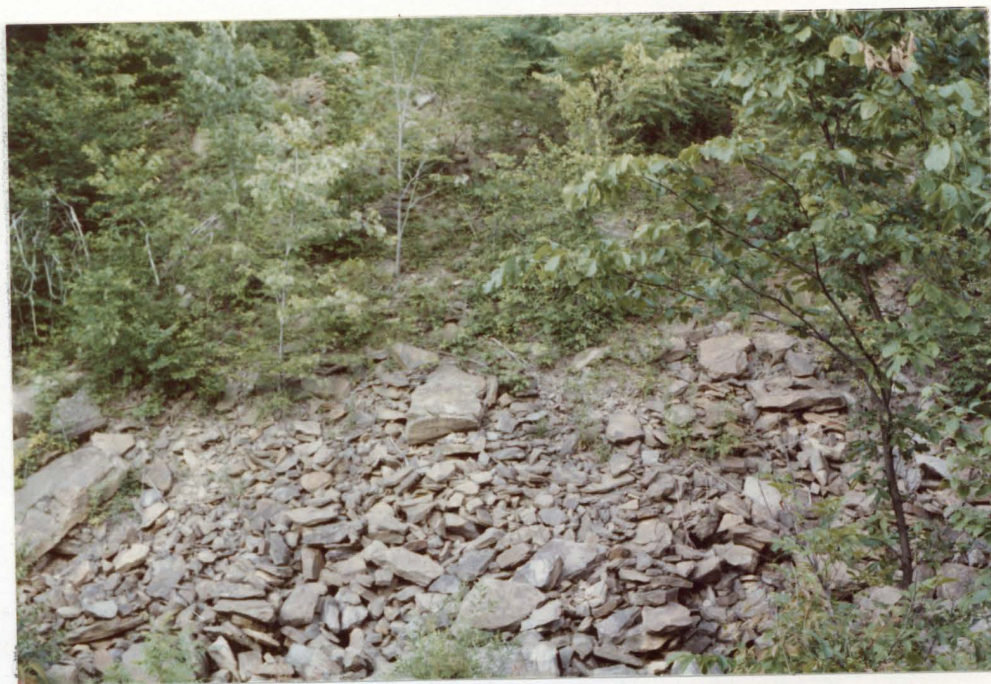
Figure 18. Talus on slope of spoil bank.

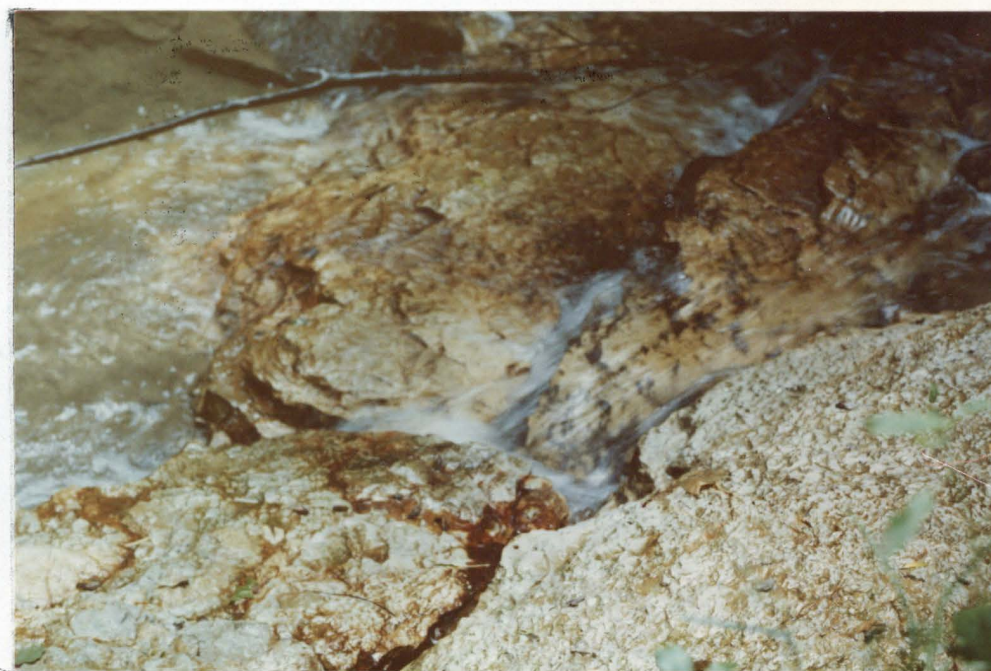
Figure 19. Sulfates contaminating tributary to Little Beaver Creek.

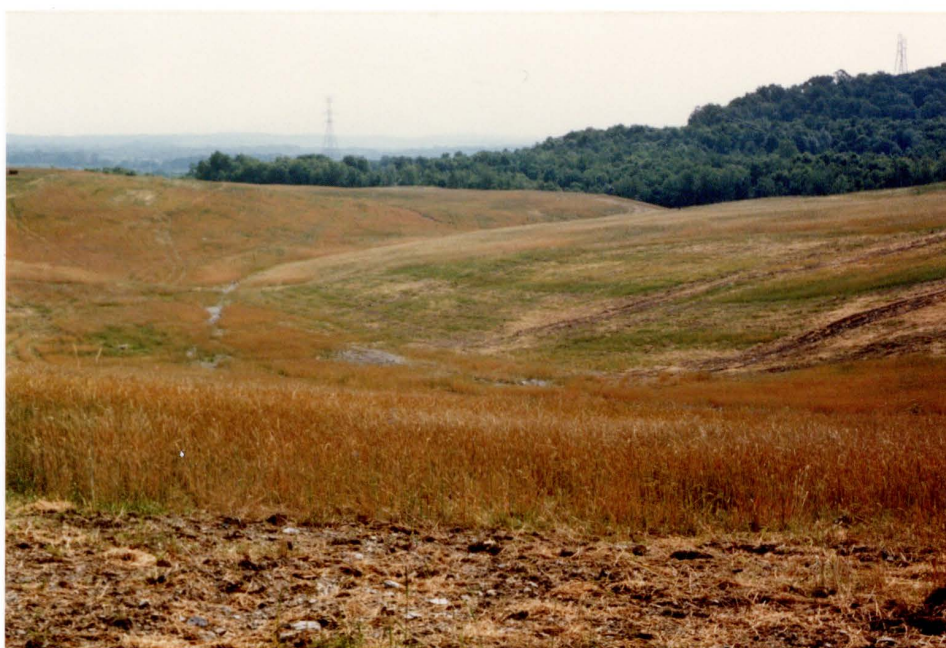
Figure 26. Recently reclaimed area, east C-1061.
Erosion, ruts and minor wet spots evident.

of Buckeye C-1061 and C-1501 by an inspector of the Division of Reclamation stated that "Rocks need to be picked. Minor erosion, wet spots and ruts need to be eliminated" (ODNR, Division of Reclamation Files). Erosion and wet spots are still evident on Figure 26 and Figure 28 in June 1985. For a comparison of before and after reclamation; C-1061, see Plate 1 and Figures 23, 24, 25 and 26; and C-1501 see Plate 2 and Figures 27 and 28. Reclamation should be approved on Buckeye C-1061 and C-1501 at the end of the 1986 growing season returning the affected area to range land.

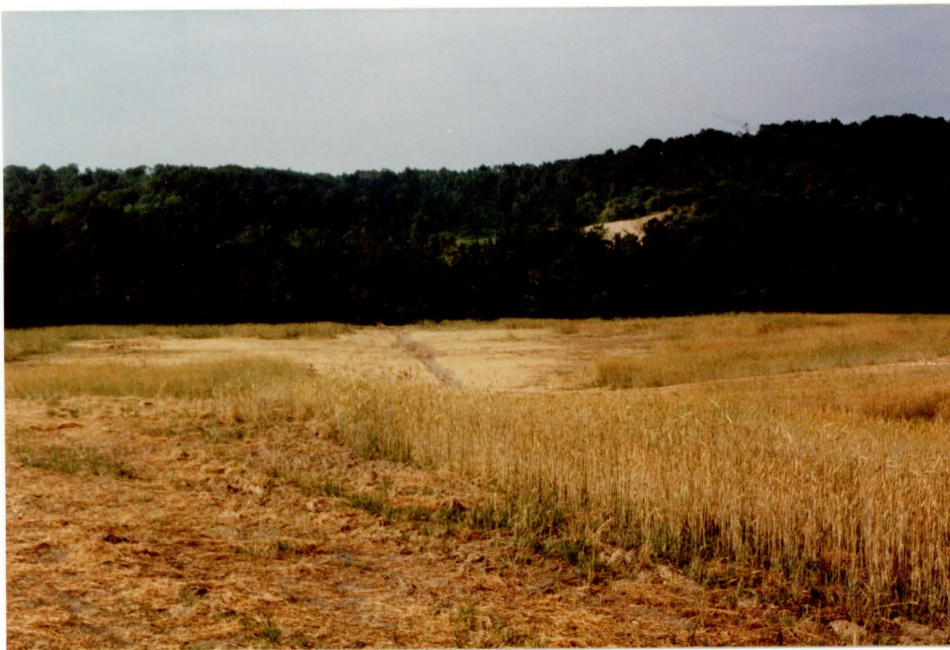
Figure 28. Recently reclaimed area C-1501 south.
Minor erosion and drainage ditch visible.

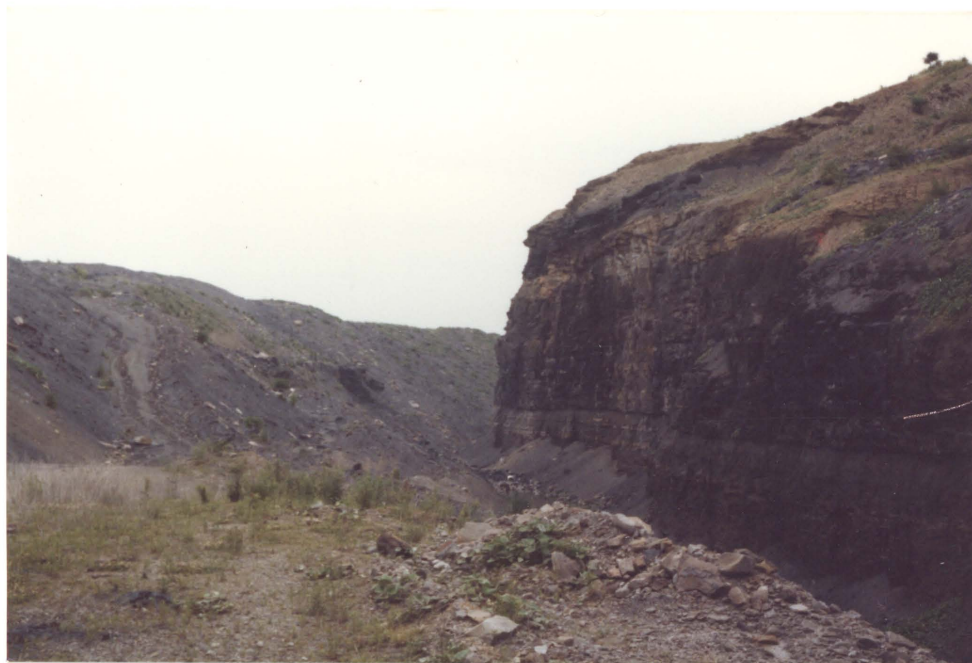
As of June 1985, the area has not been reclaimed to it's original contour and the remaining spoil will not fill the pit. The C-1109 has a potentially dangerous highwall which will most likely have to be shot off to fill the pit and remove the danger. In this case, fines and the most important deterring factor (possibility of not receiving future permits because of bond forfeiture) were not sufficient enough to make the C & W Mining Company reclaim C-1109 suitably.

Figure 29b. Highwall south C-1109.

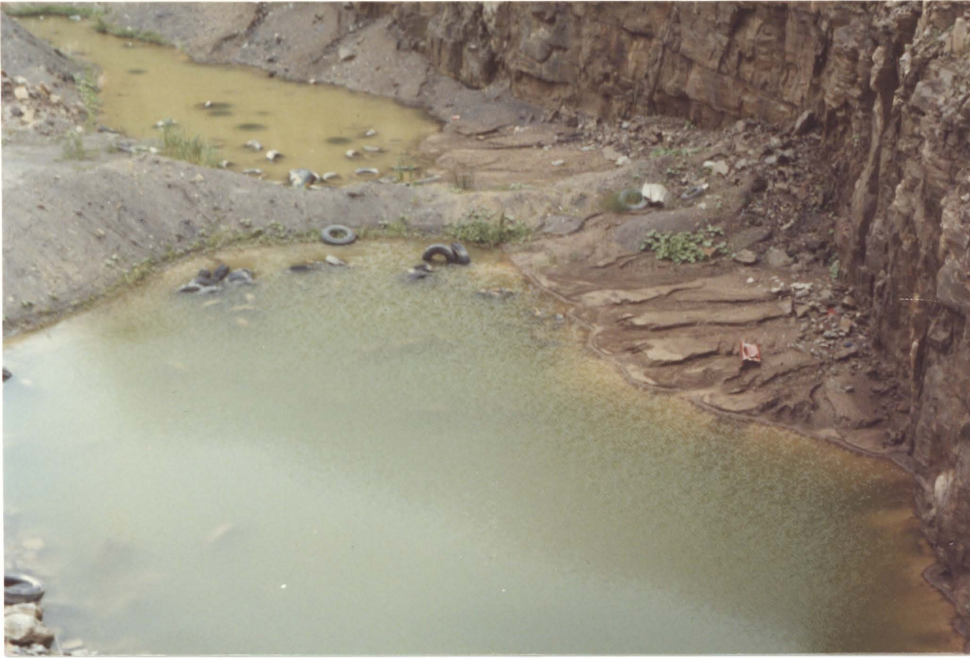
Figure 33. Impoundment of water below highwall C-1109.

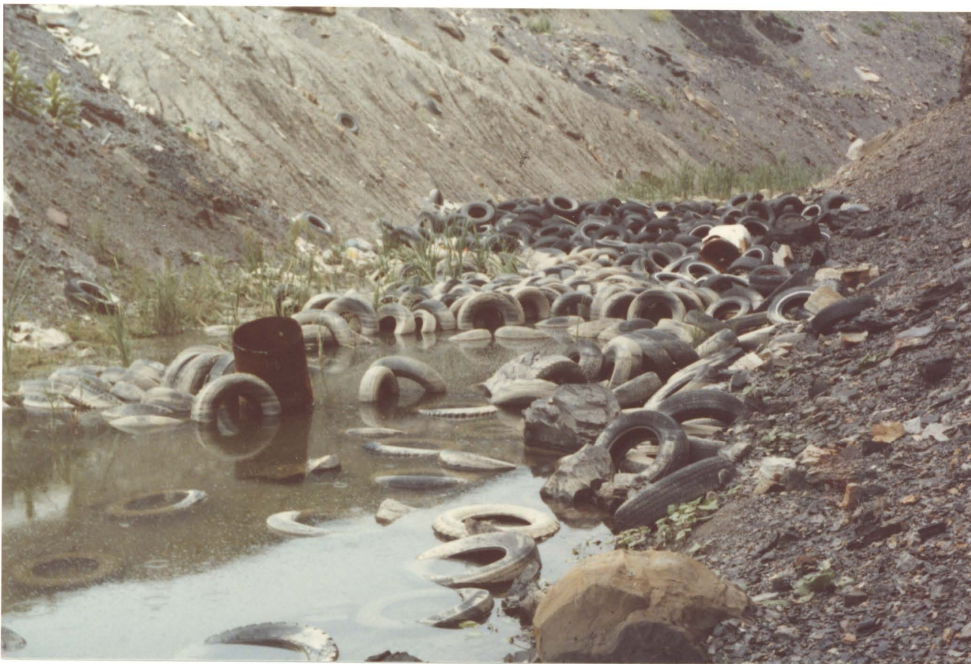
Figure 34. Tires in final cut C-1109.

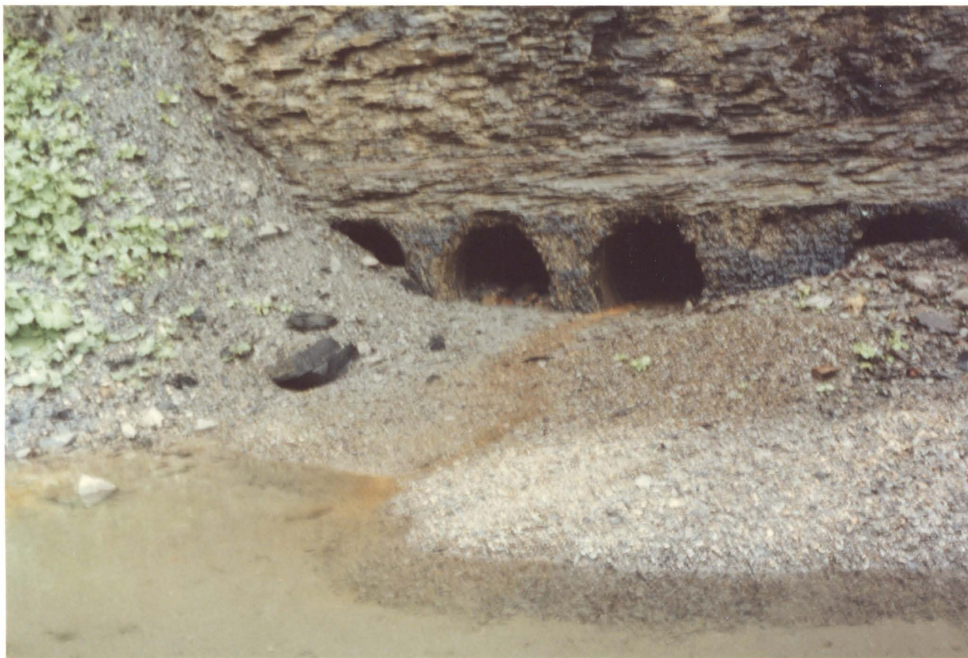
Figure 35. Sulfates running from auger hole.

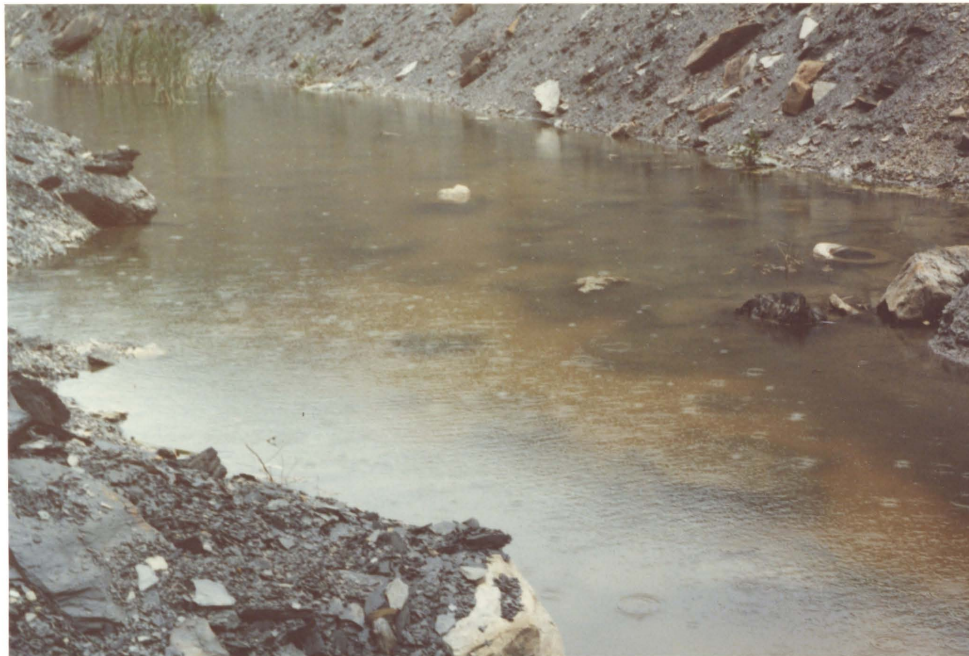
Figure 36. Sulfates in impounded water.

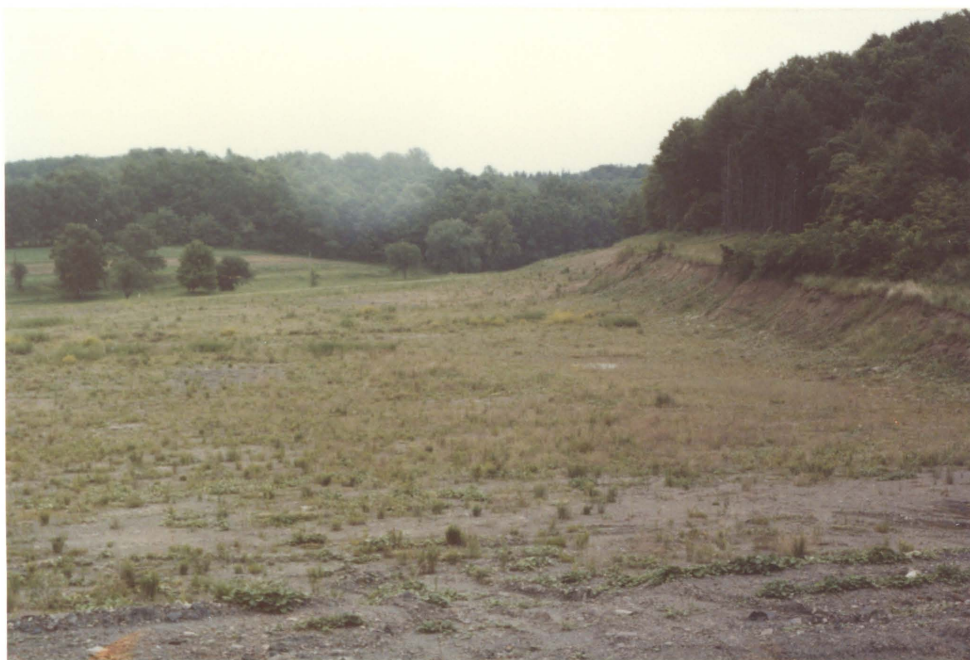
Figure 37. Evidence in change of contour of graded area, east C-1109.

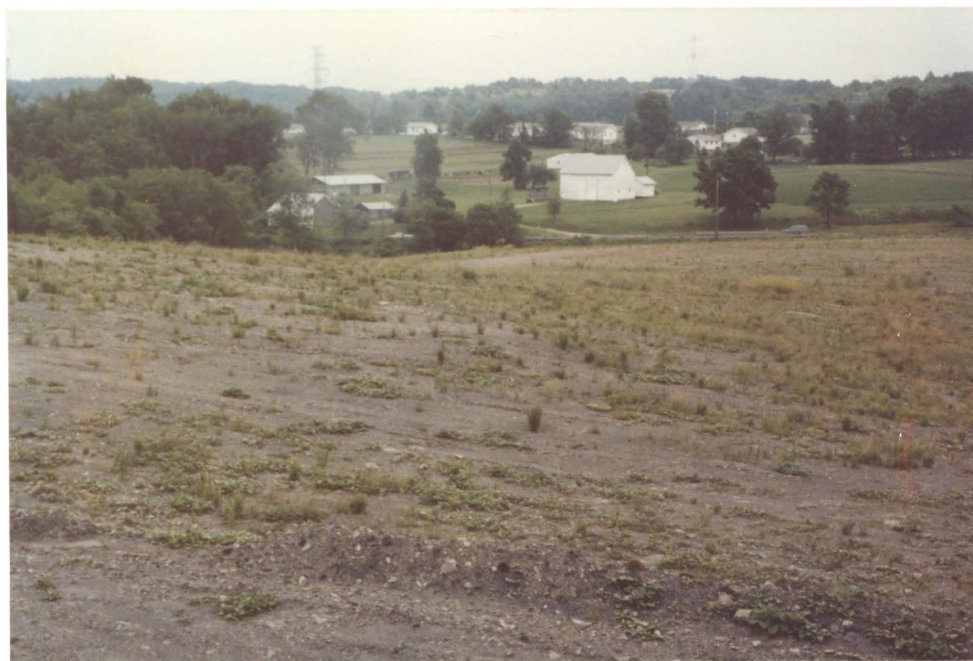
Figure 38. Unsuitably reclaimed area with spoil material exposed at graded surface.

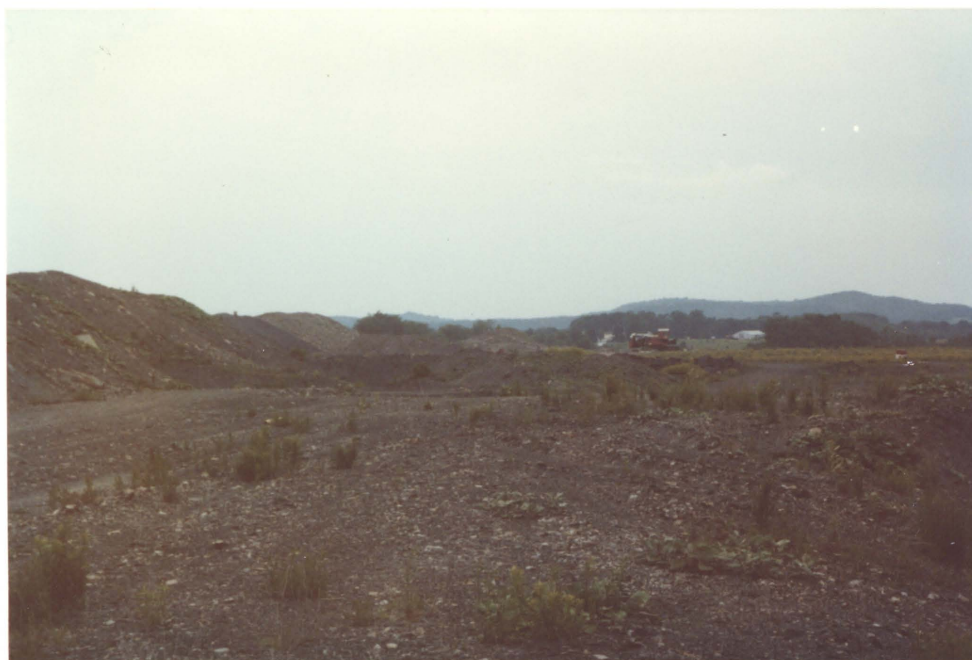
Figure 39. Unreclaimed spoil.

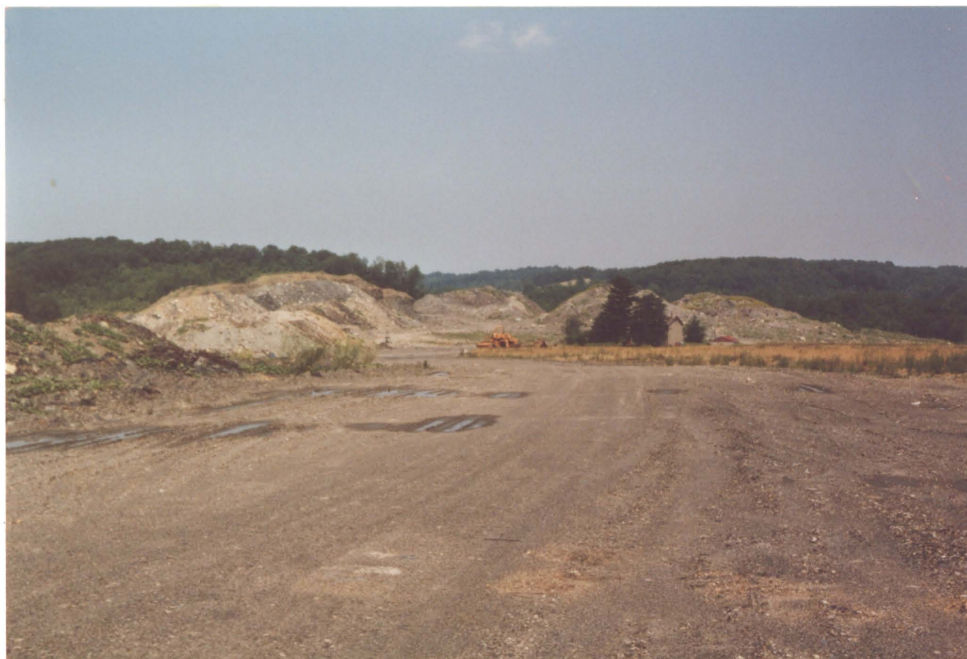
Plate 5 is an aerial photo of C-1453 in June 1982 during active mining. Figures 45 through 51 depict current conditions of site C-1453. Figure 45 shows Miller house with spoil in foreground (north) and highwall and spoil in background (southwest of house). Figure 46 is a picture looking north at the Miller house surrounded by spoil.

Figure 46. Looking north at Miller house surrounded by spoil.

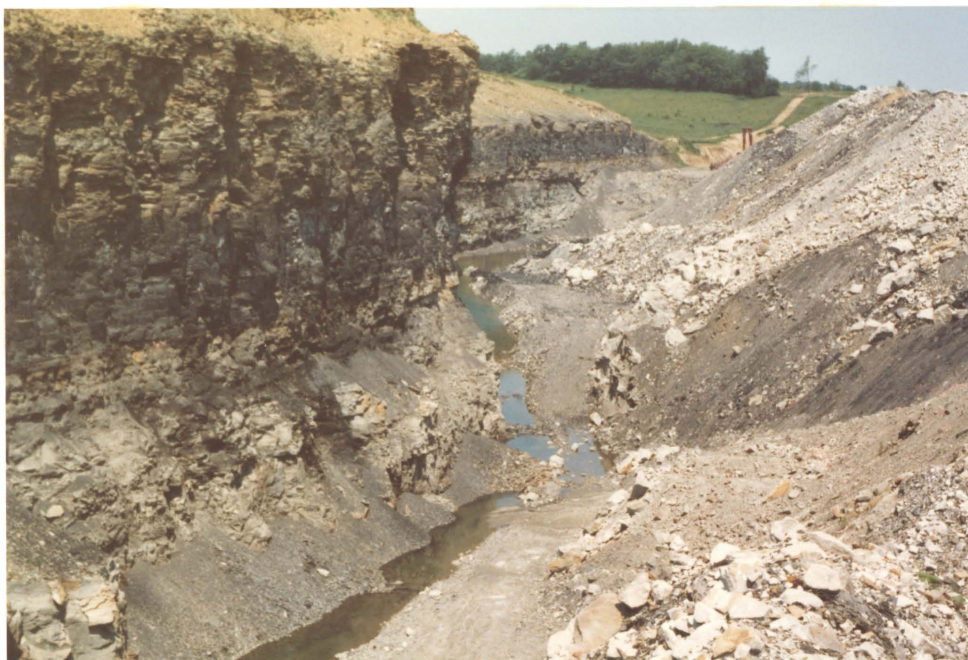
Figures 47 and 48 are pictures of existing highwall which extends approximately 8500 feet and ranges from 40 to 140 feet in height. Figure 49 depicts a drainage ditch above highwall on western section of C-1453. Figure 50 is a view southeast of Miller house and no cost reclamation section. A no cost reclamation area is a previous abandoned mine area which the strip mine operator may use to dump spoil or store equipment as long as he reclaims it after use. The no cost section of C-1453 comes under The Abandon Mined Lands, Division of Reclamation. The no cost land reclamation project on C-1453 is a cheap way for the state to have the land reclaimed and at the same time, a cheap way to dispose of spoil by the operator. In the case of C-1453 no cost project, the contour of the land was raised and an insufficient amount of topsoil was placed above spoil material (Fig. 50 and 51). The higher contour of the no cost project has resulted in surface water to runoff to the Miller house and other nearby residents, whose dwellings are now lower than the surrounding affected land. At present, it seems that the unreclaimed C & W C-1453 site will remain in the condition it is now until C & W Mining Company litigates it's reorganization. It is also the author's understanding that the state will make allowances to C & W to get them to reoccupy the C-1453 site. The reason for the state's allowances are because if left to the State of Ohio to reclaim C-1453, it would cost millions.

Figure 47. 140 foot high highwall.

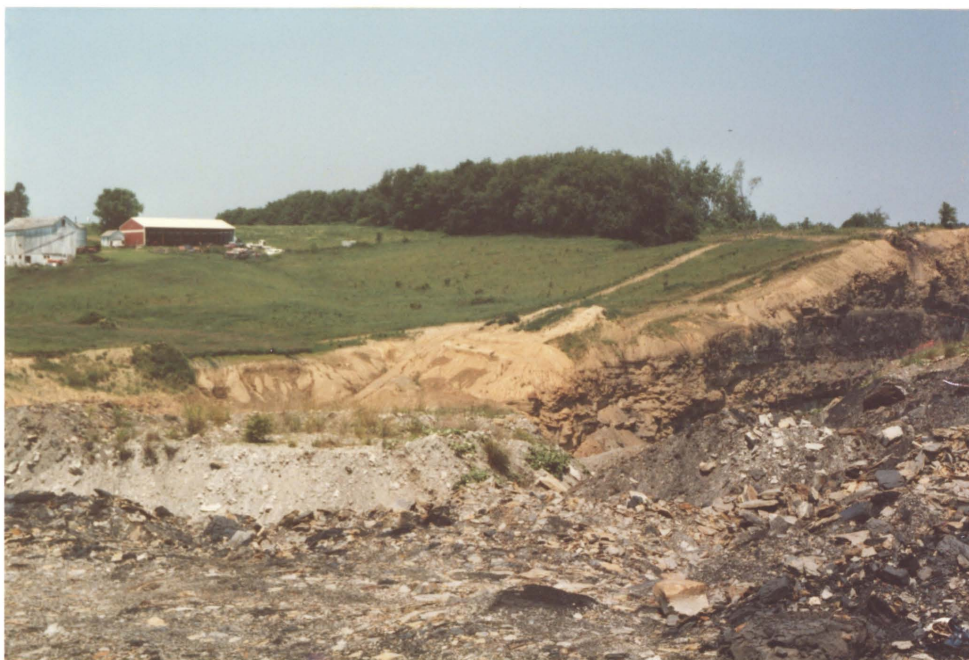
Figure 49. Drainage ditch above highwall west C-1453.

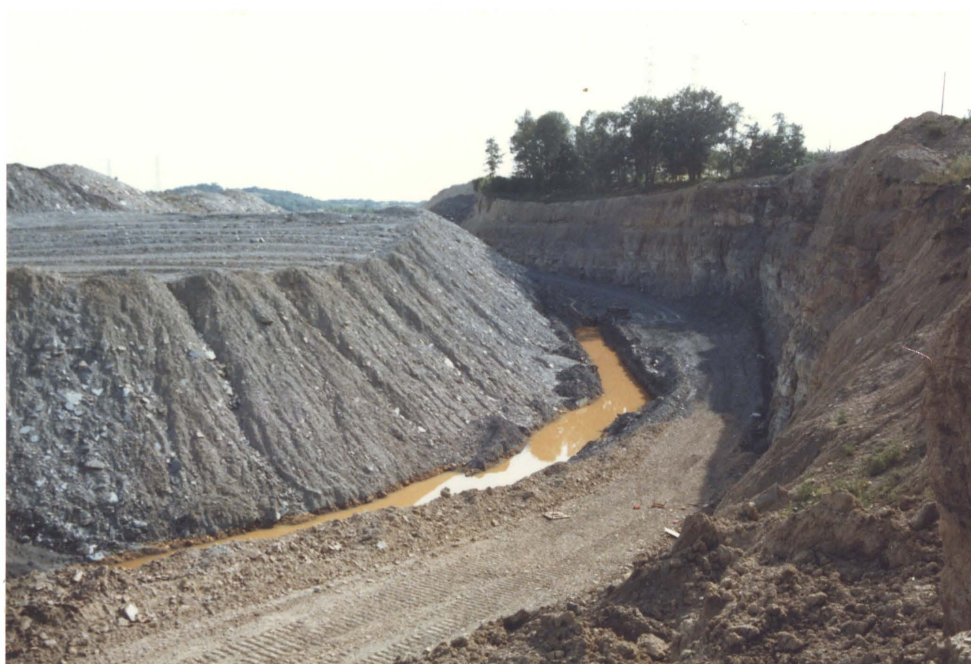
Figure 54. Sag pond in northwest corner of D-40.
